CONFIDENTIAL INSPECTION REPORT

2 Dobbin Lane Rolling Hills Estates, CA.

06/16/2004 11:30 am to 1:30 pm

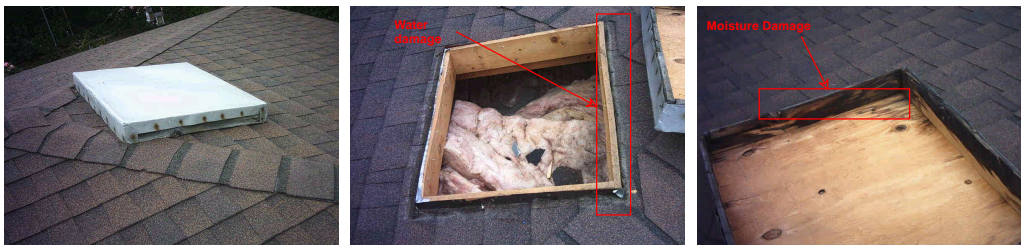
There is an access panel on the top of the shingle roof. This is a very unusual location, as elements may quickly break-down the roofing materials. We recommend further evaluation by a licensed roofing contractor.

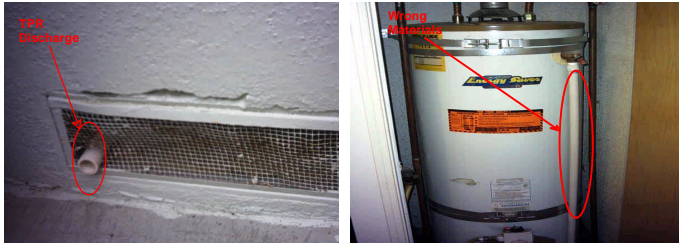
The discharge pipe from the pressure relief valve on the water heater should be plumbed in metal, or an approved material, and should extend to the exterior and terminate no more than twenty-four inches above

grade and no less than six inches to it.

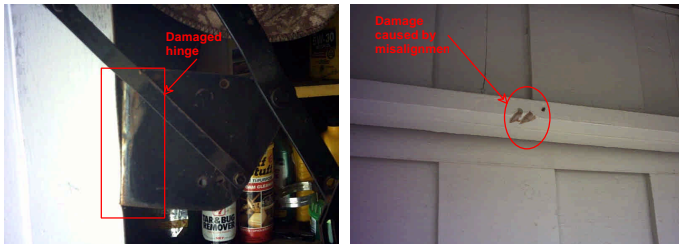
The main garage door is not aligned squarely in its opening, and should be evaluated by a specialist.
